DS N°8 5 doors/ 5 seats/ Hatchback (2025/ ->)

1. Identification / recognition

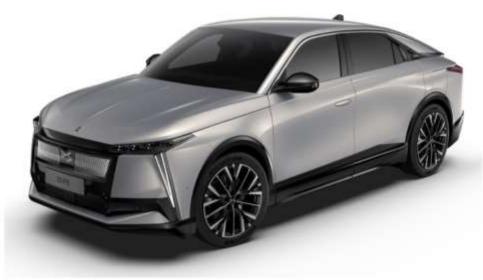
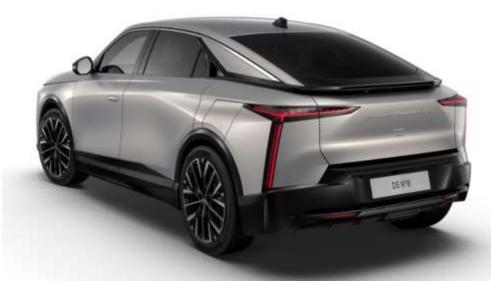
| | Airbag | | Stored gas inflator | Seat belt pretensioner | SRS control unit | | |
| | | | Gas strut / Preloaded spring | High strength zone | | 4 | High voltage component |
| 000 000 | Battery low voltage | | | | | | |
| | Battery pack, high- voltage | 1 | High voltage power cable | | | | |
| x | Cable cut | % | Low voltage device that disconnects high voltage | | | | |

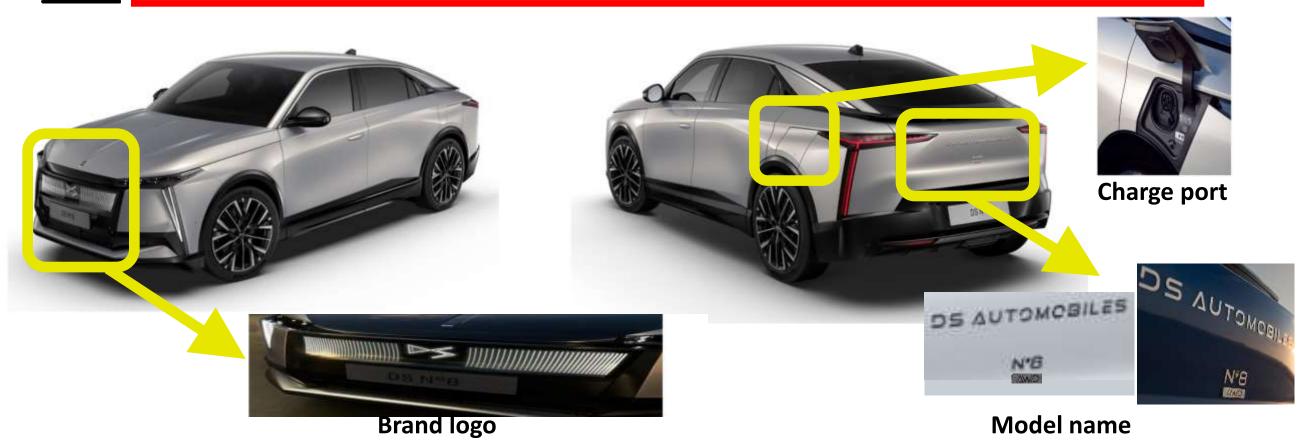
LACK OF ENGINE NOISE DOES NOT MEAN VEHICLE IS OFF, SILENT MOVEMENT OR INSTANT RESTART CAPABILITY EXISTS UNTIL VEHICLE IS FULLY SHUT DOWN. WEAR APROPRIATE PPE.

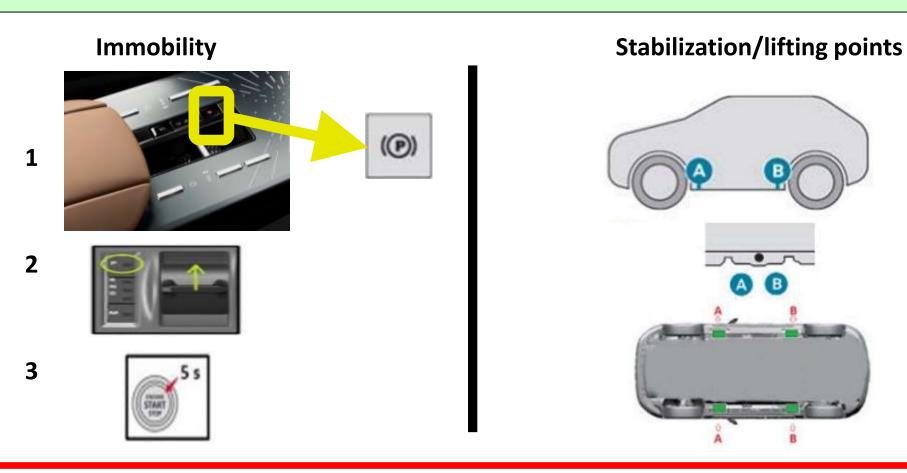
2. Immobilisation / stabilisation / lifting

Do not place cribbing such as wooden blocks or rescue air lifting bags under the fuel system or high voltage power cables. Doing so may result in fuel leaks, fire, or electric shock.

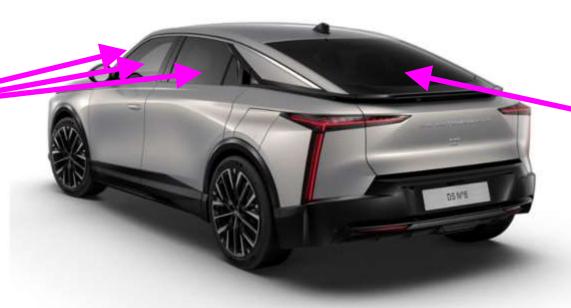
Glass types

Toughened glass

High strength steel body
