NEW COMPASS MY25 BEV
5 doors/ 5 seats/ SUV
(2025/ ->)

1. Identification / recognition

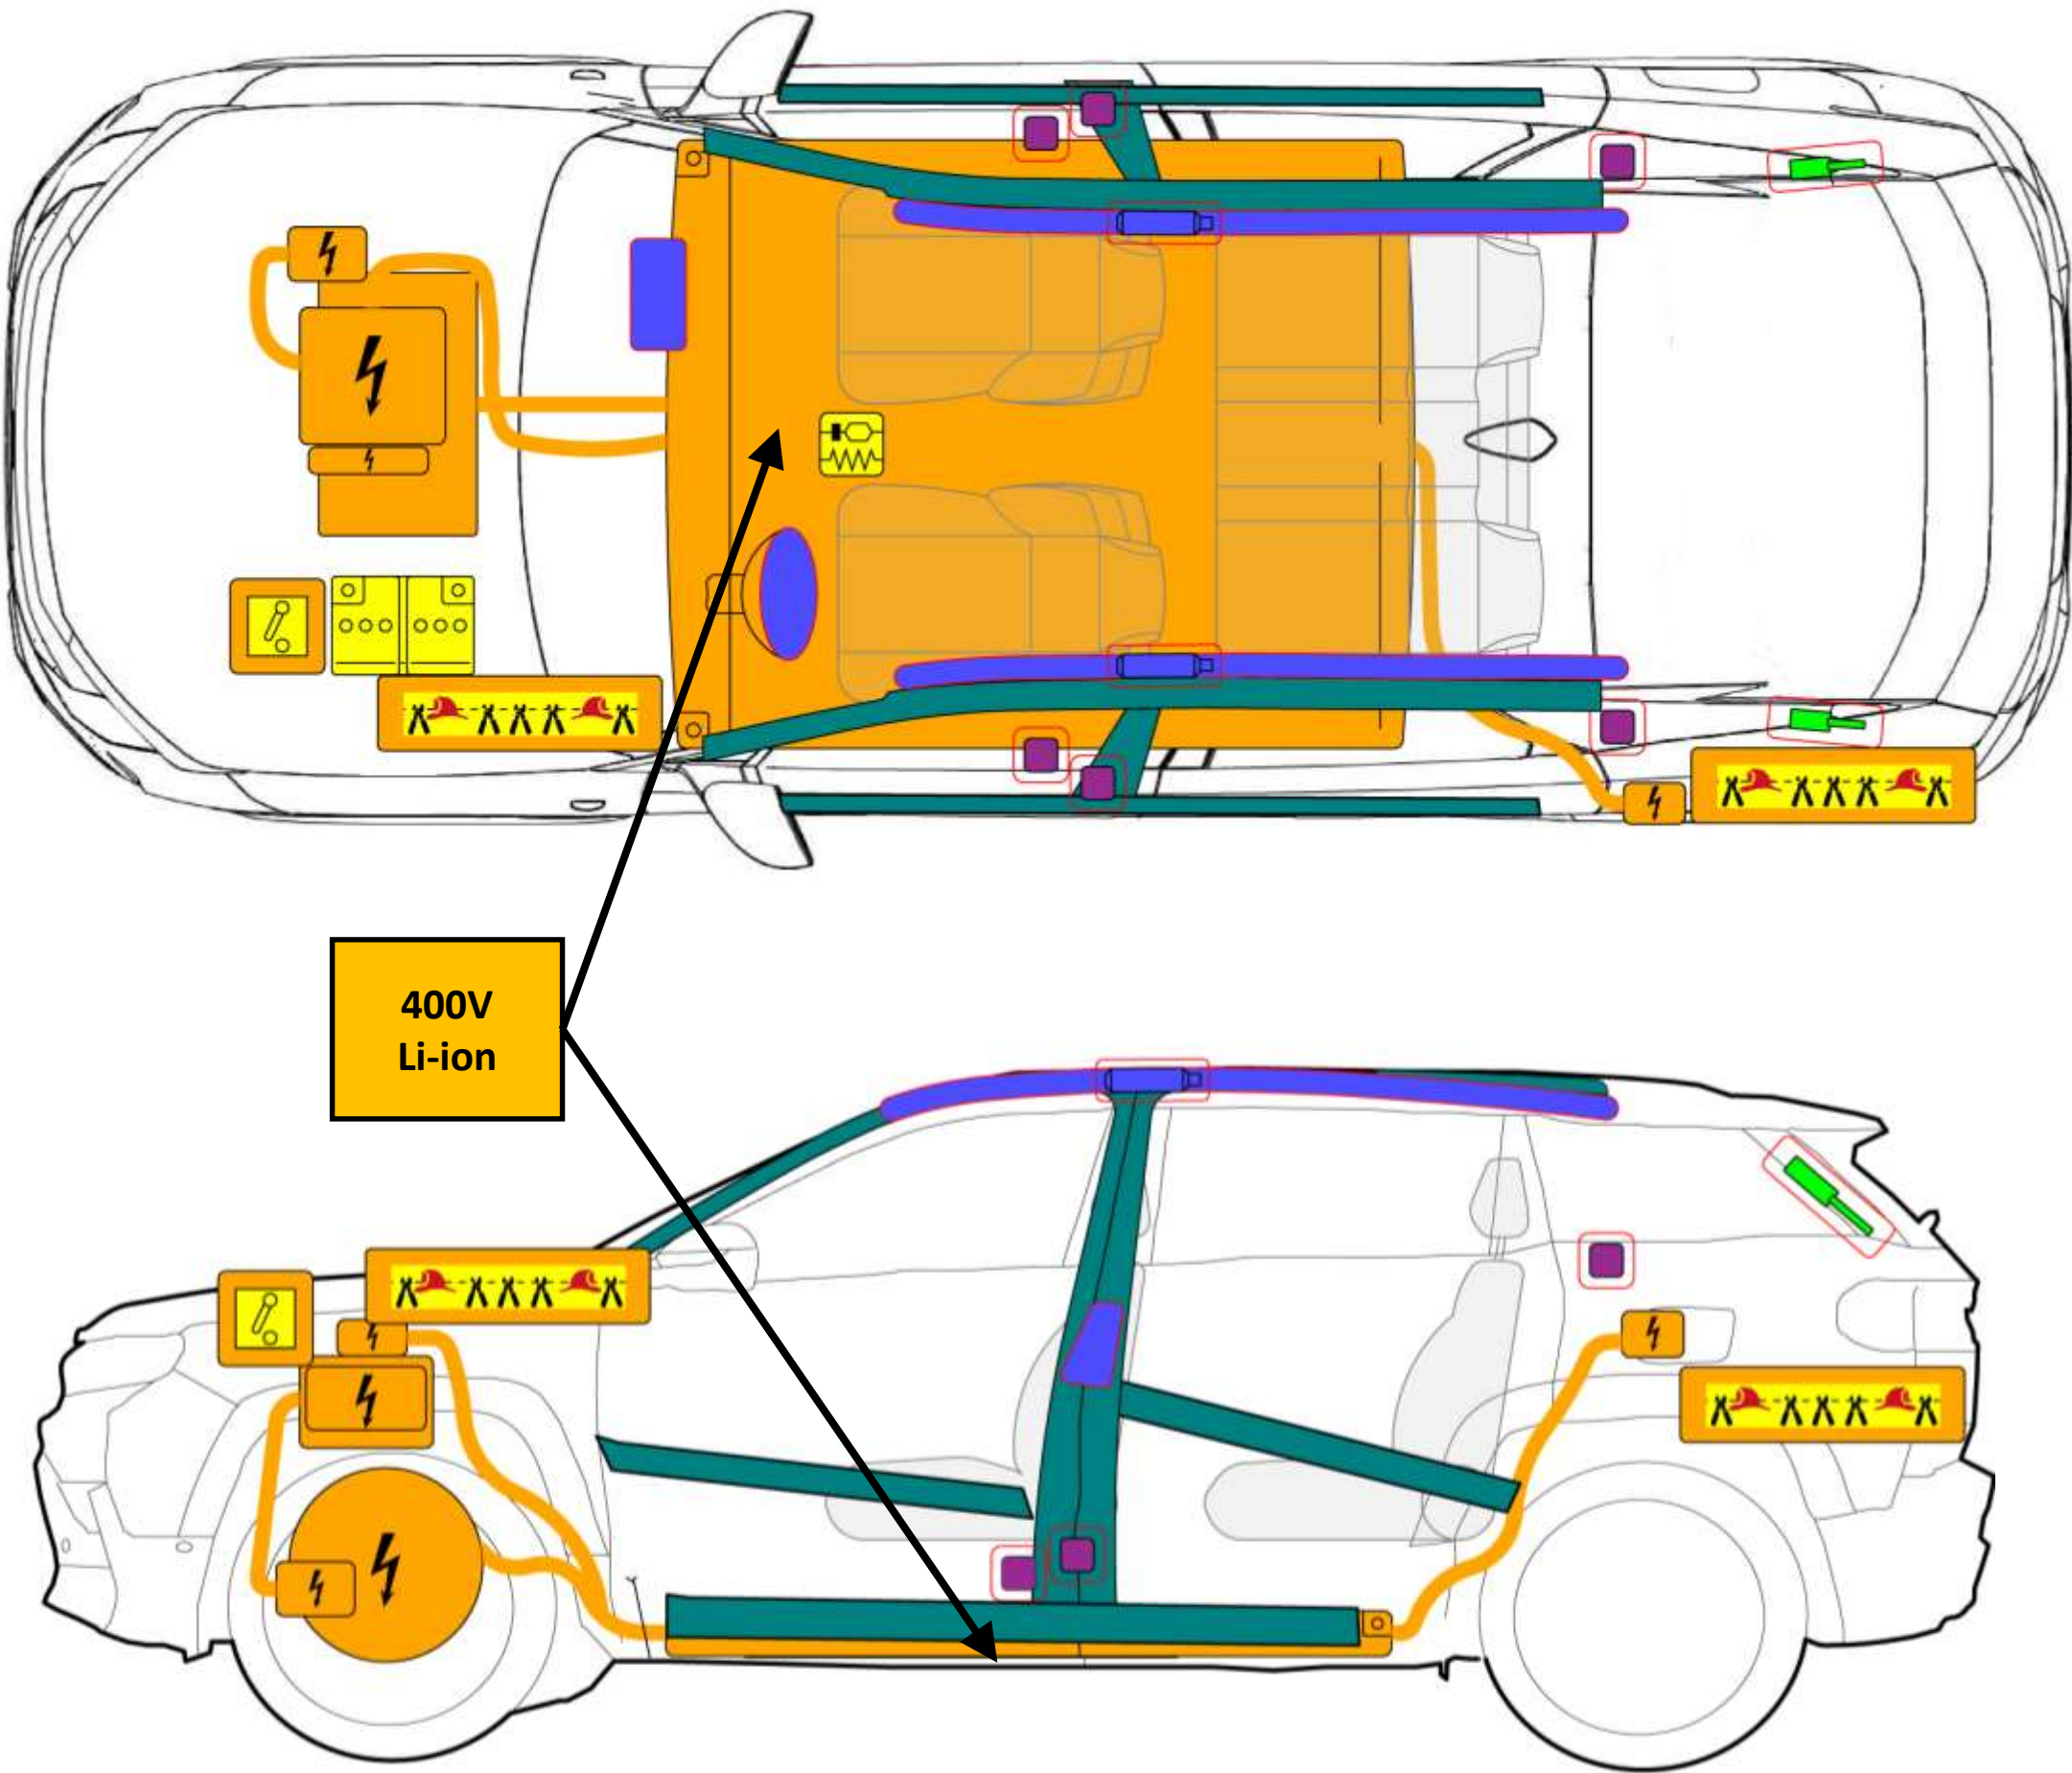
| | Airbag | | Stored gas inflator | | Seat belt pretensioner | | SRS control unit | | |
| | | | Gas strut / Preloaded spring | | High strength zone | | | | High voltage component |
| | Battery low voltage | | | | | | | | |
| | Battery pack, high-voltage | | High voltage power cable | | | | | | |
| | Cable cut | | Low voltage device that disconnects high voltage | | | | | | |

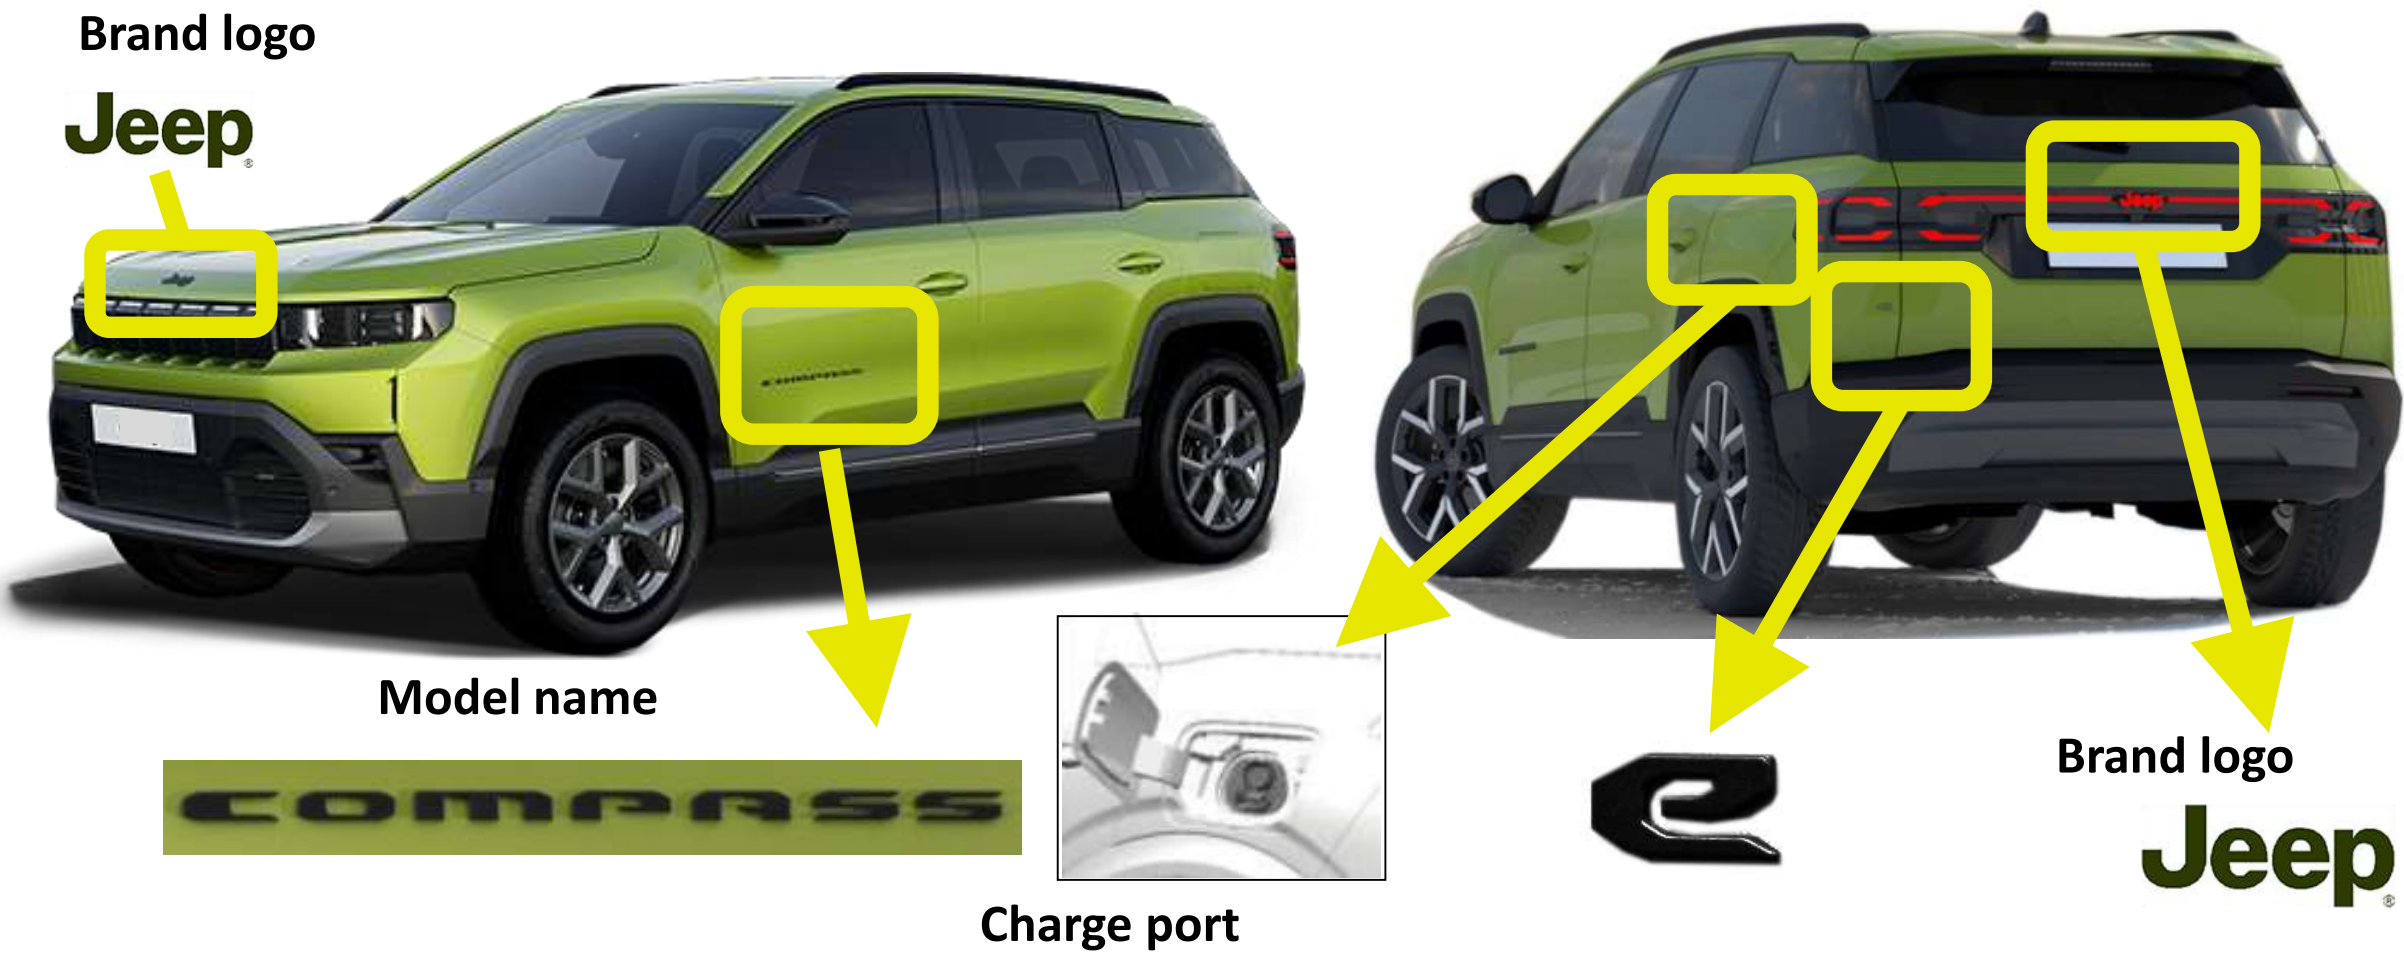
Brand logo

Model name

Charge port

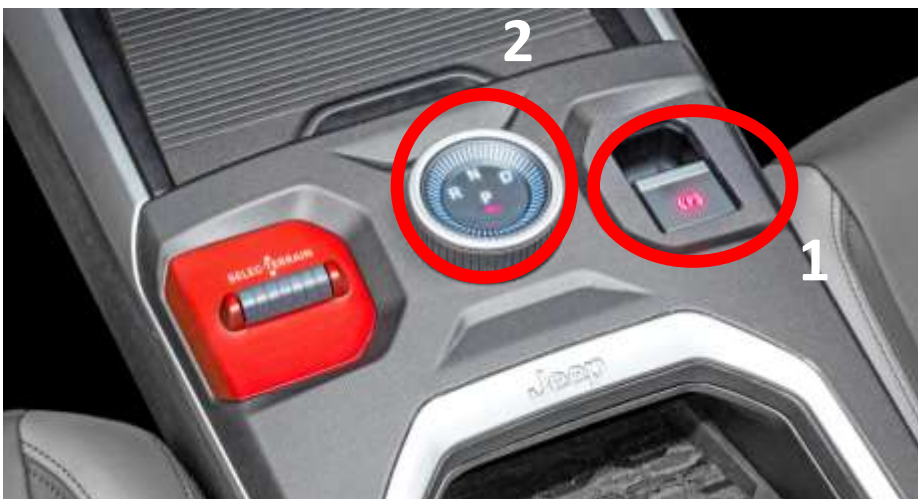
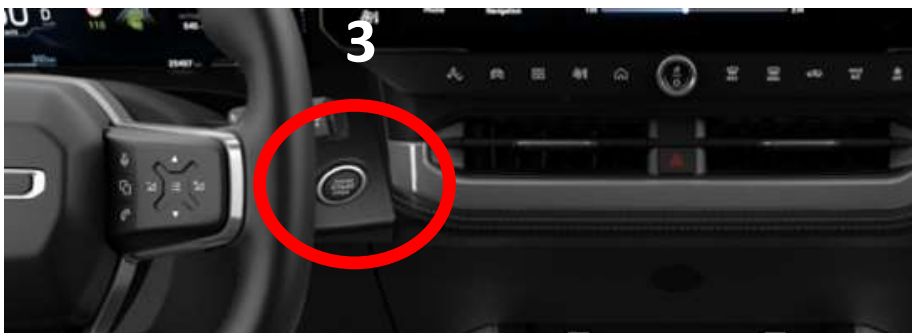
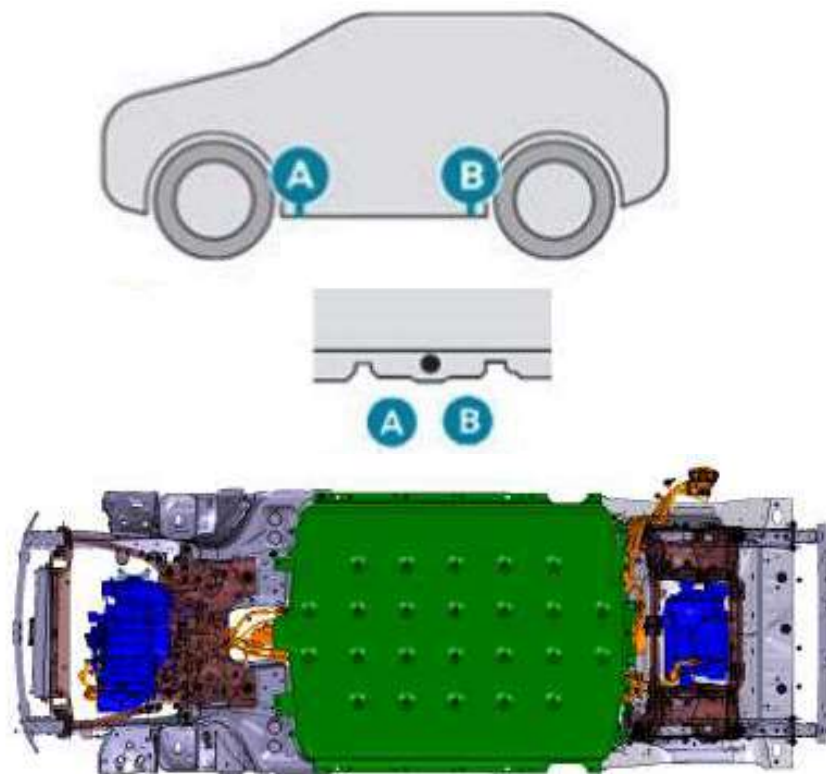
Stabilization/lifting points

Immobility

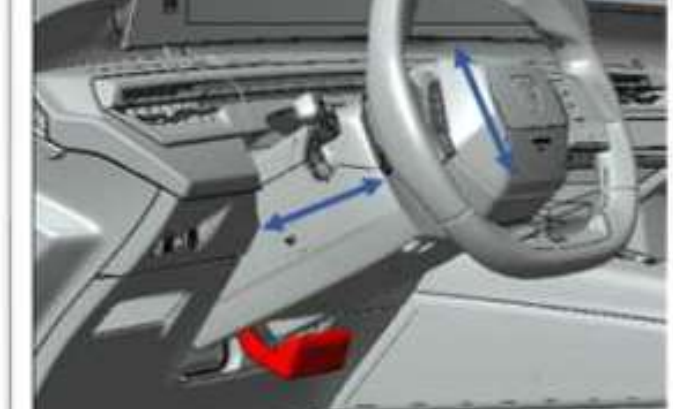
High strength steel body

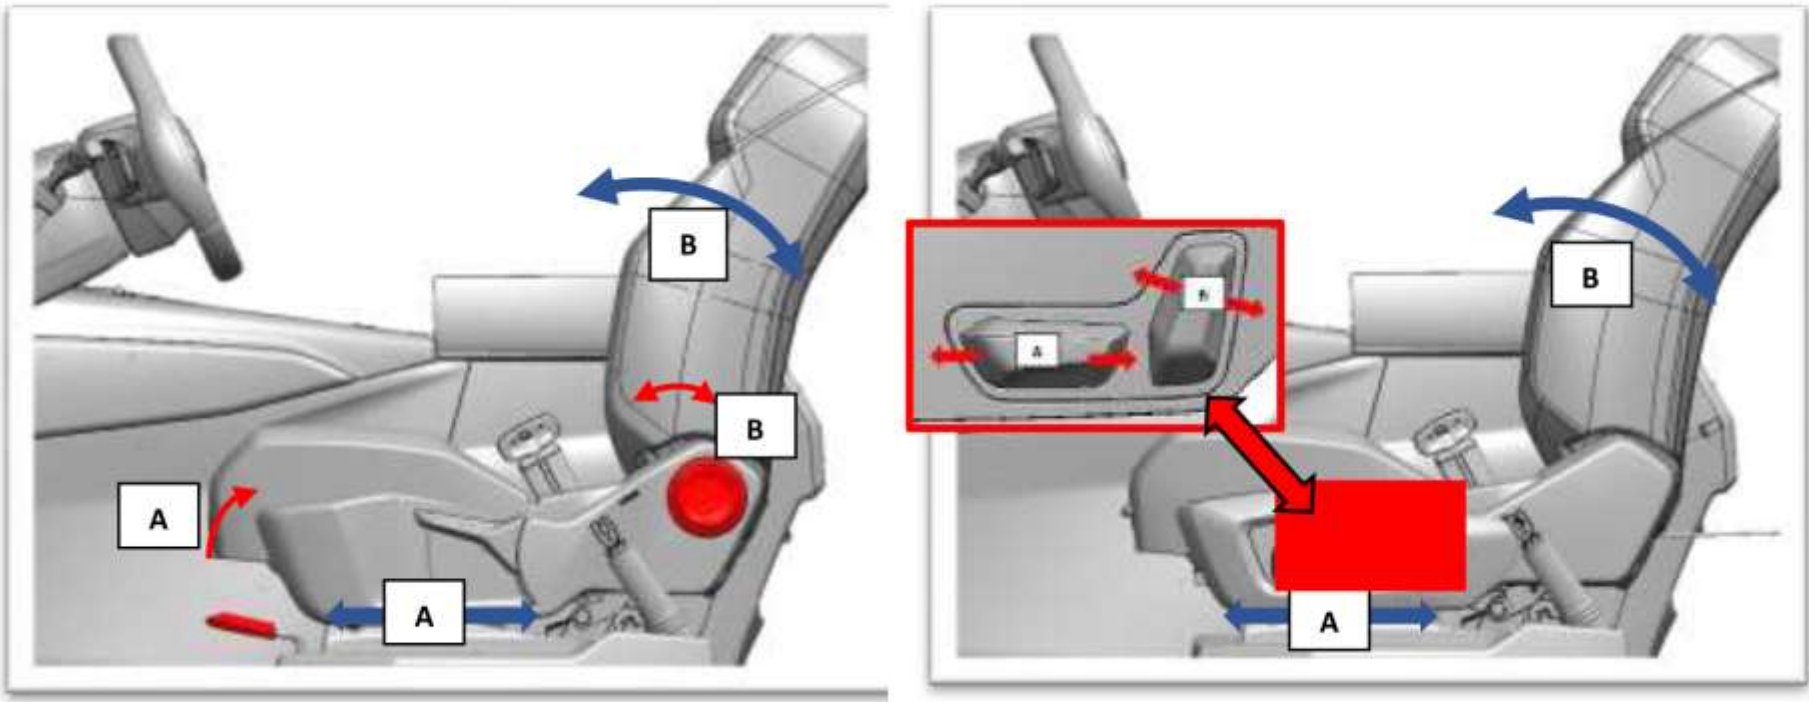
Seat adjustment

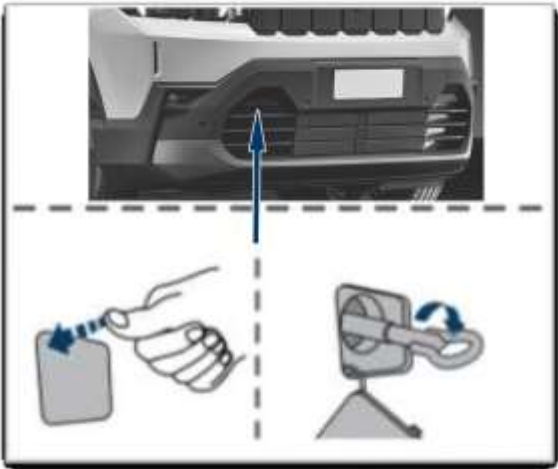
Location front hook

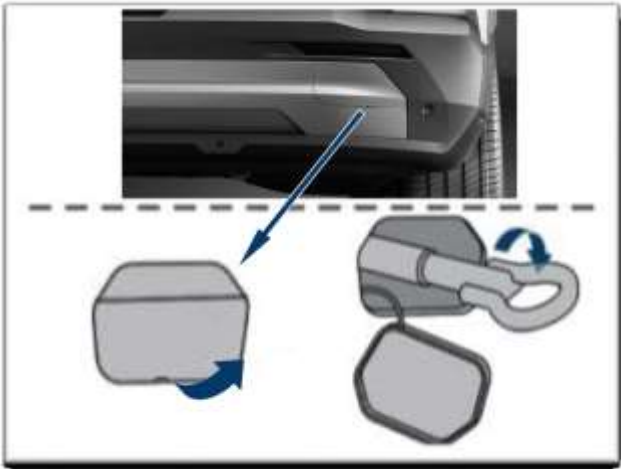
Location rear hook

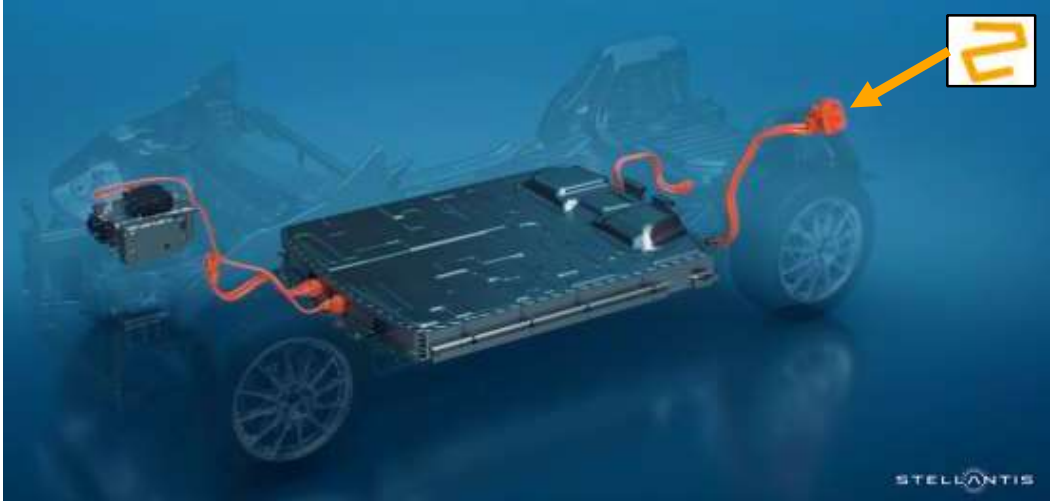
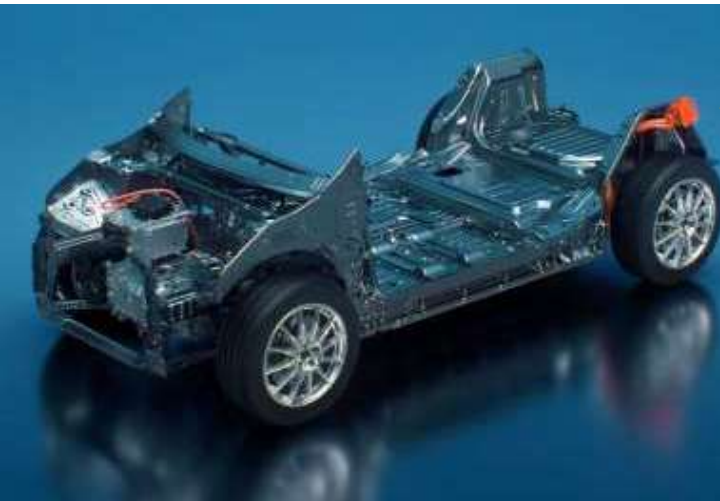
High voltage power cable
