# Peugeot e3008

5 doors/ 5 seats/ Sedan BEV FWD (2023/ -> )

STELLANTIS	ID N°	Version N°	Version date	Page
STELEMATIS	01365_24_00334	OR	12.12.24	1/4

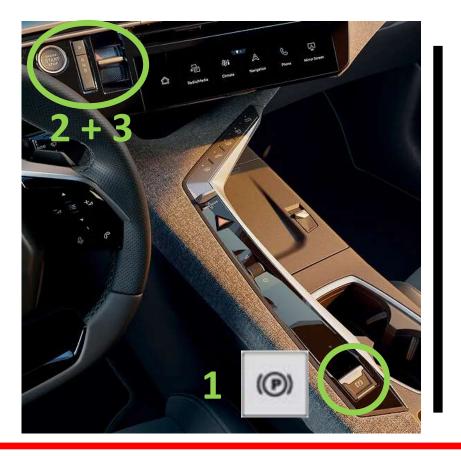
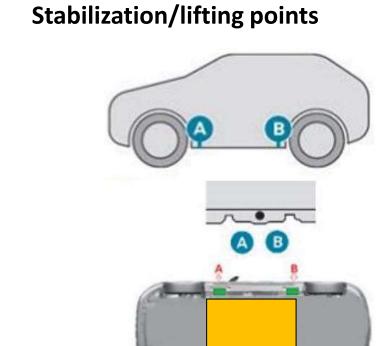
#### 2. Immobilisation / stabilisation / lifting

Do not place cribbing such as wooden blocks or rescue air lifting bags under the fuel system or high voltage power cables. Doing so may result in fuel leaks, fire, or electric shock.

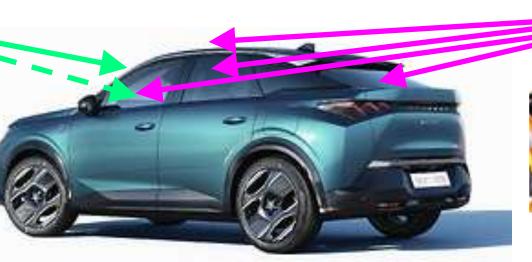
**Glass types**

(serial production) (optional product)

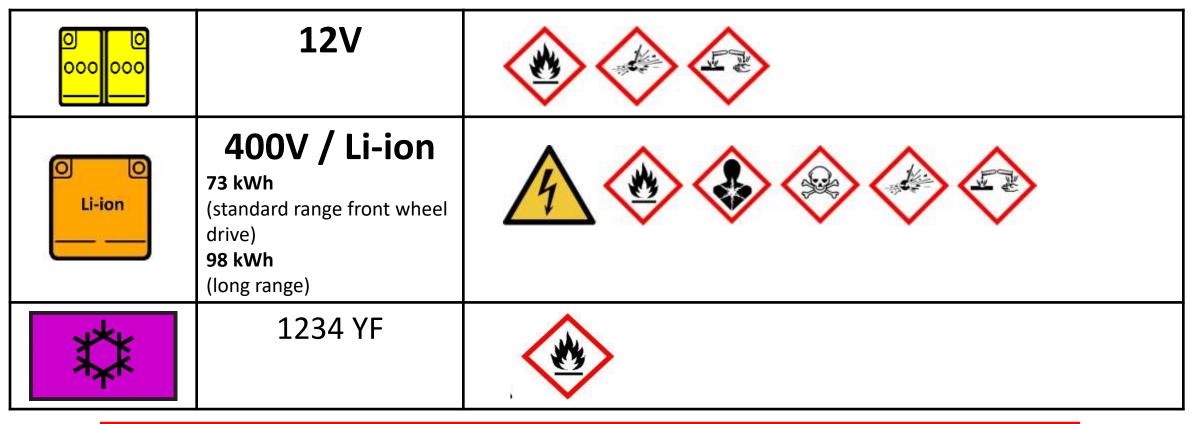
#### 5. Stored energy / liquids / gases / solids

when coolant leaks from the battery pack, it can become unstable with risk of thermal runaway. Check battery pack temperature with thermal imaging camera.

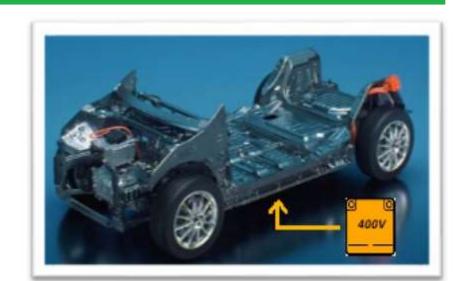
#### Use large amount of water

Lithium-ion batteries may self-ignite or reignite once the fire has been extinguished. Monitor the temperature of the high-voltage battery!
