Peugeot e5008

5 doors/ 5-7 places/ SUV BEV (2024/ ->)

1. Identification / recognition

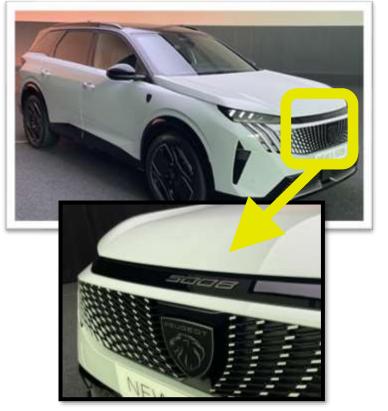
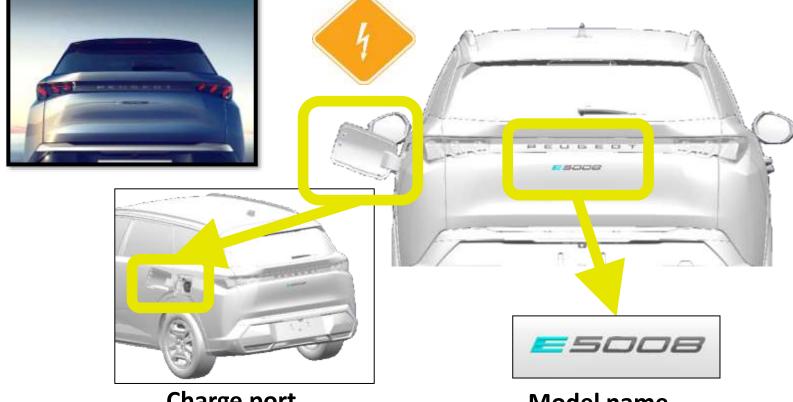
Brand logo

Charge port

Model name

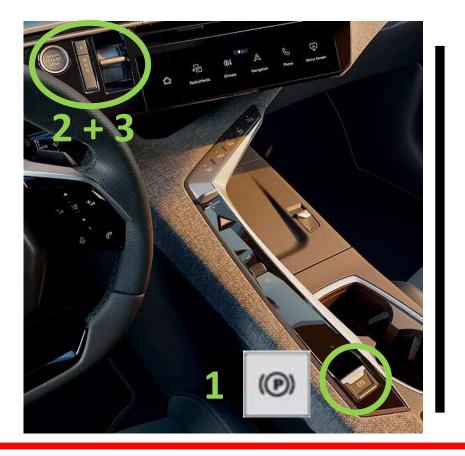
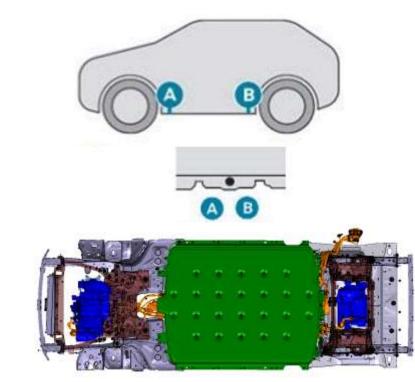
Stabilization/lifting points

Do not place cribbing such as wooden blocks or rescue air lifting bags under the fuel system or high voltage power cables. Doing so may result in fuel leaks, fire, or electric shock.

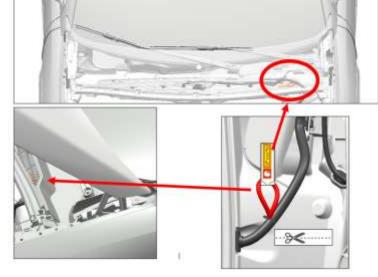
Main disabling method

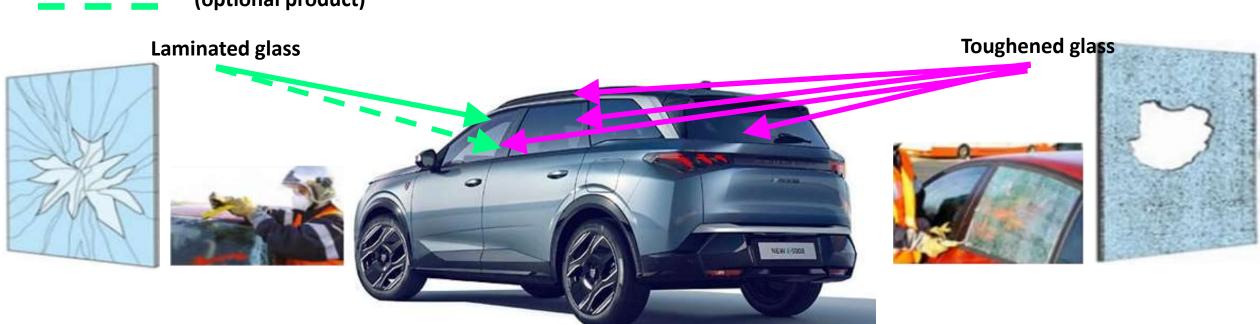
Glass types

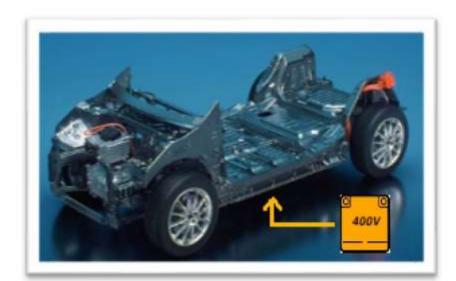
Use large amount of water

Lithium-ion batteries may self-ignite or reignite once the fire has been extinguished. Monitor the temperature of the high-voltage battery!
