XPENG G6

5 doors / 5 seats / SUV From 2024

XPENG G6	ID No.	Version No.	Page No.
FROM 2024-PRESENT	L1N-G6-2024-ERS	O1	2/4

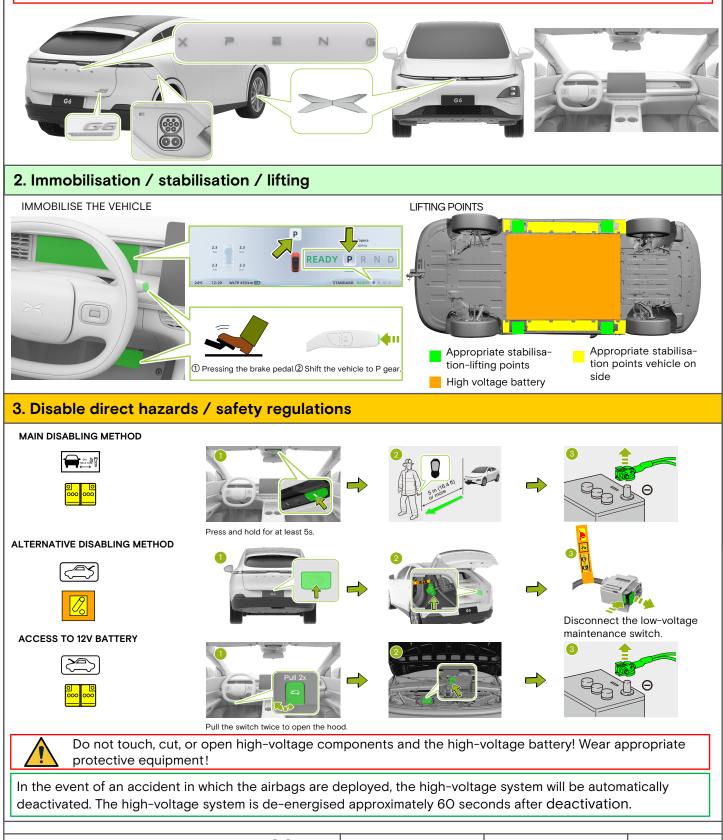
1. Identification / recognition

LACK OF ENGINE NOISE DOES NOT MEAN VEHICLE IS OFF: SILENT MOVEMENT OR INSTANT RESTART CAPABILITY EXISTS UNTIL VEHICLE IS FULLY SHUT DOWN. WEAR APPROPRIATE PPE.

Driver's seat has a far side airbag in addition to the side airbag. Location of far side airbag is shown in the mark. 9. on page 1.

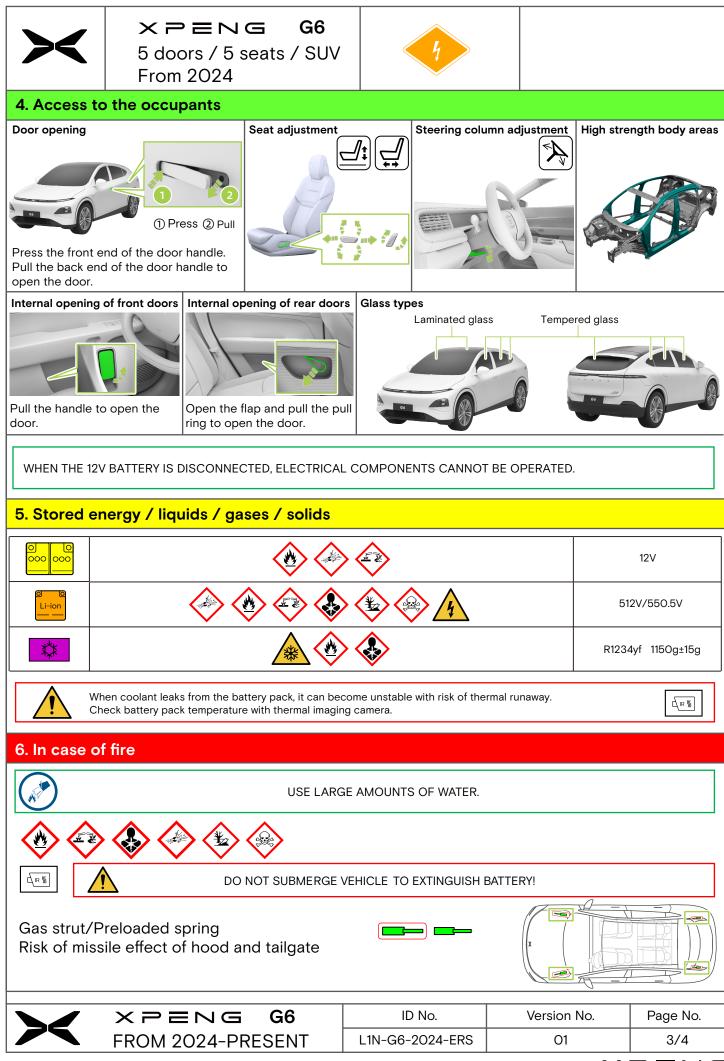
7. In case of submersion

Proper PPE should be worn when handling any flooded vehicle. Pull the vehicle out of water as much as possible, immobilise the vehicle and disable the vehicle before starting any operation (see chapter 3). Tilt the vehicle to one side to allow water to drain out of the vehicle.

8. Towing / transportation / storage

Always transport with all four tires off of the ground.
