XPENG P7

4 doors sedan
From 2023

L1N-P7-2023-ERS

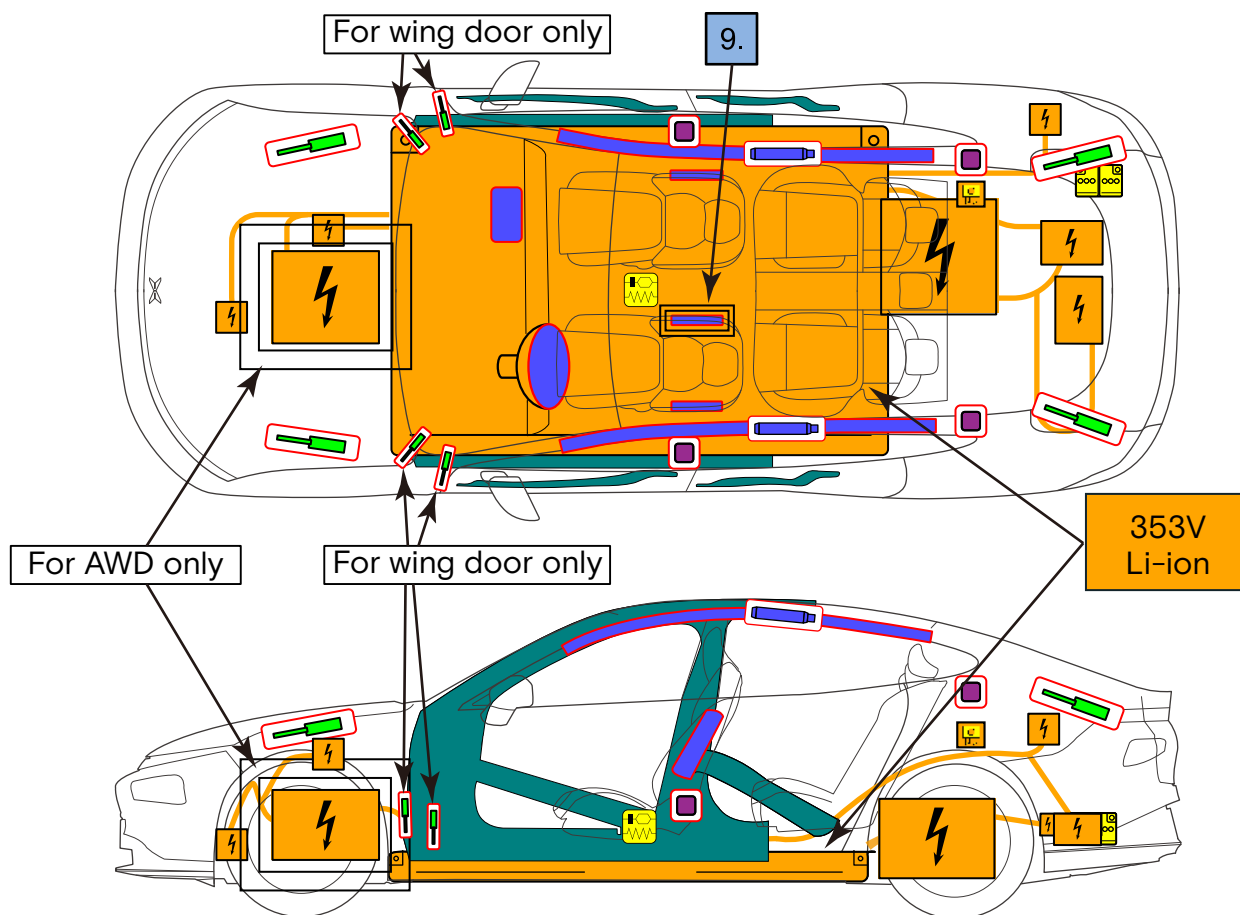
Airbag		Stored gas inflator		Seat belt pretensioner		SRS control unit
	Battery Low Voltage		Gas strut/Preloaded spring		High strength zone		Zone requiring special attention
	High voltage component		Battery pack, high-voltage		High voltage power cable		Fuse box disabling high voltage

Driver's seat has a far side airbag in addition to the side airbag. Location of far side airbag is shown in the mark.

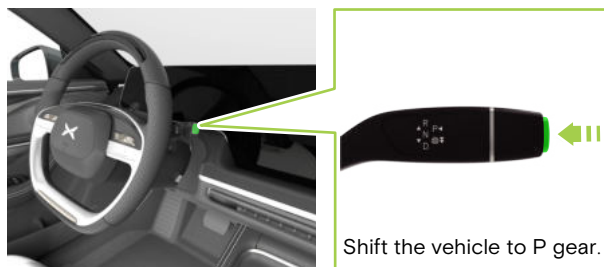
IMMOBILISE THE VEHICLE

Shift the vehicle to P gear.

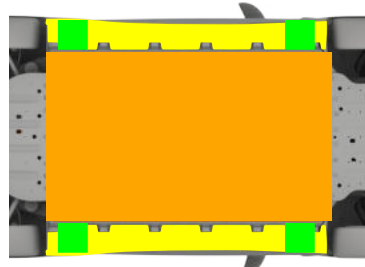
LIFTING POINTS

- Appropriate stabilisation-lifting points
- Appropriate stabilisation points vehicle on side
- High voltage battery

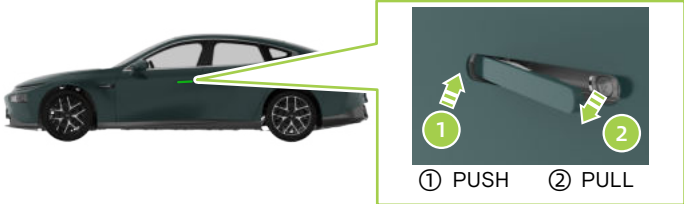
Door opening

Press the front end of the door handle. Pull the back end of the door handle to open the door.

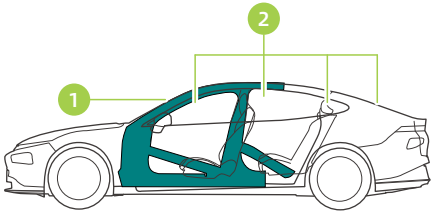
High strength body areas

Glas types:
 ① Laminated glass
 ② Tempered glass
